133 HOUNDSDITCH – Before and After

Photographs on the following pages show the dramatic upgrade to the entrance and interior of 133 Houndsditch on behalf of our client Henderson Global Investors.

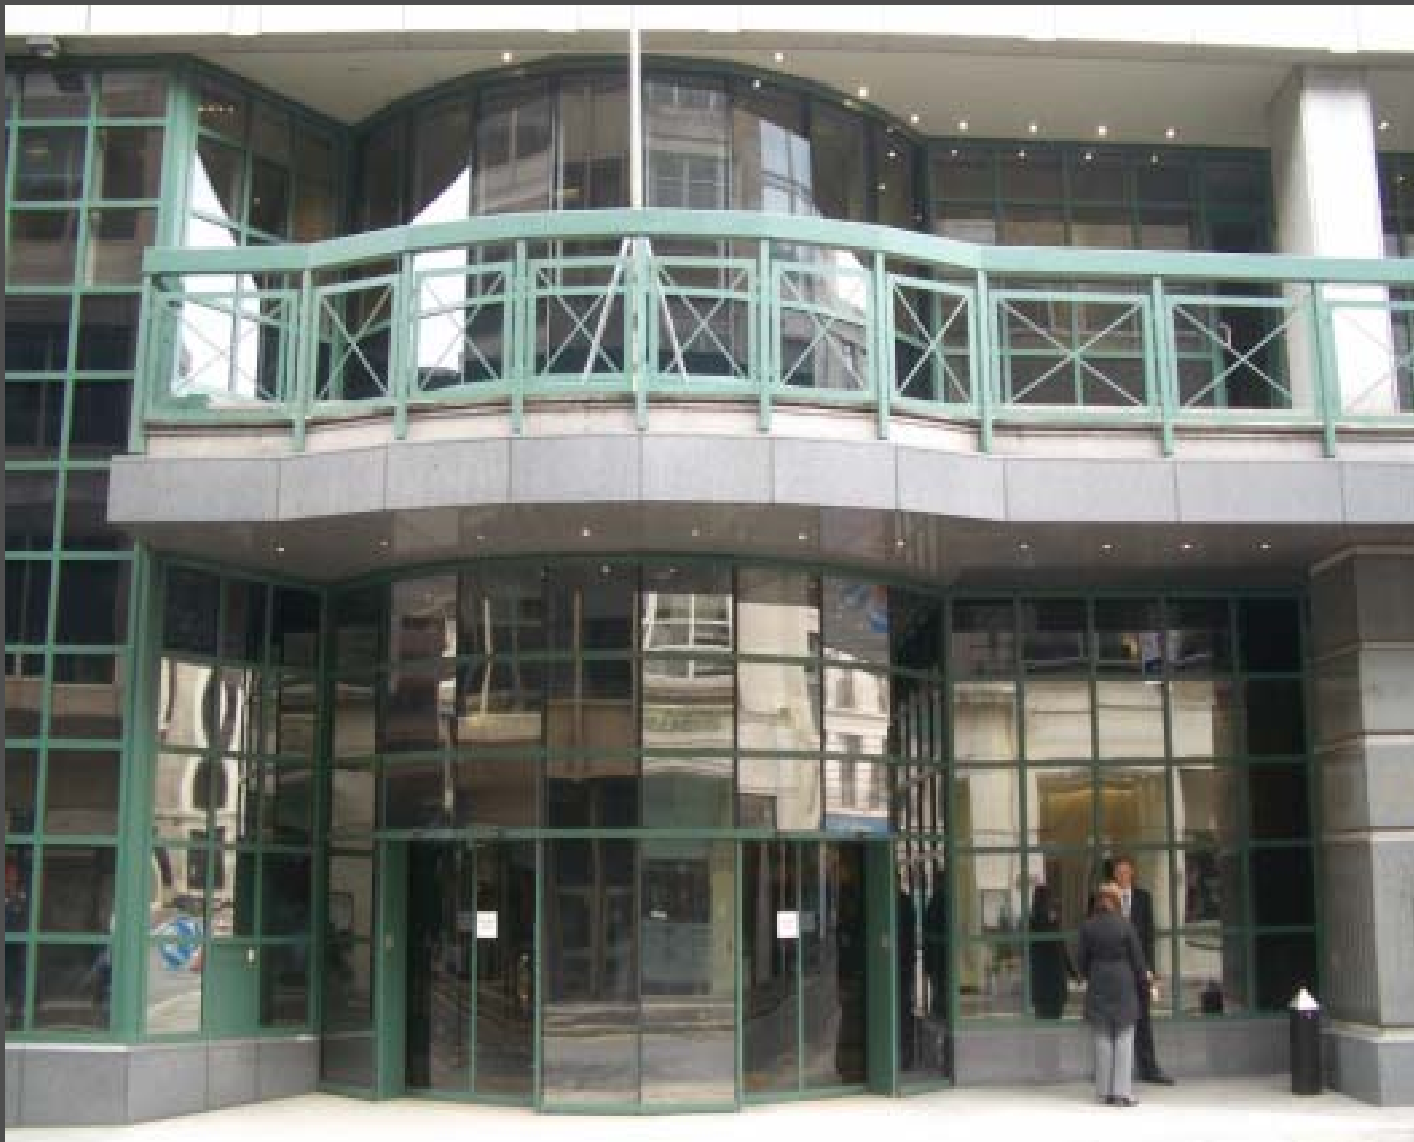
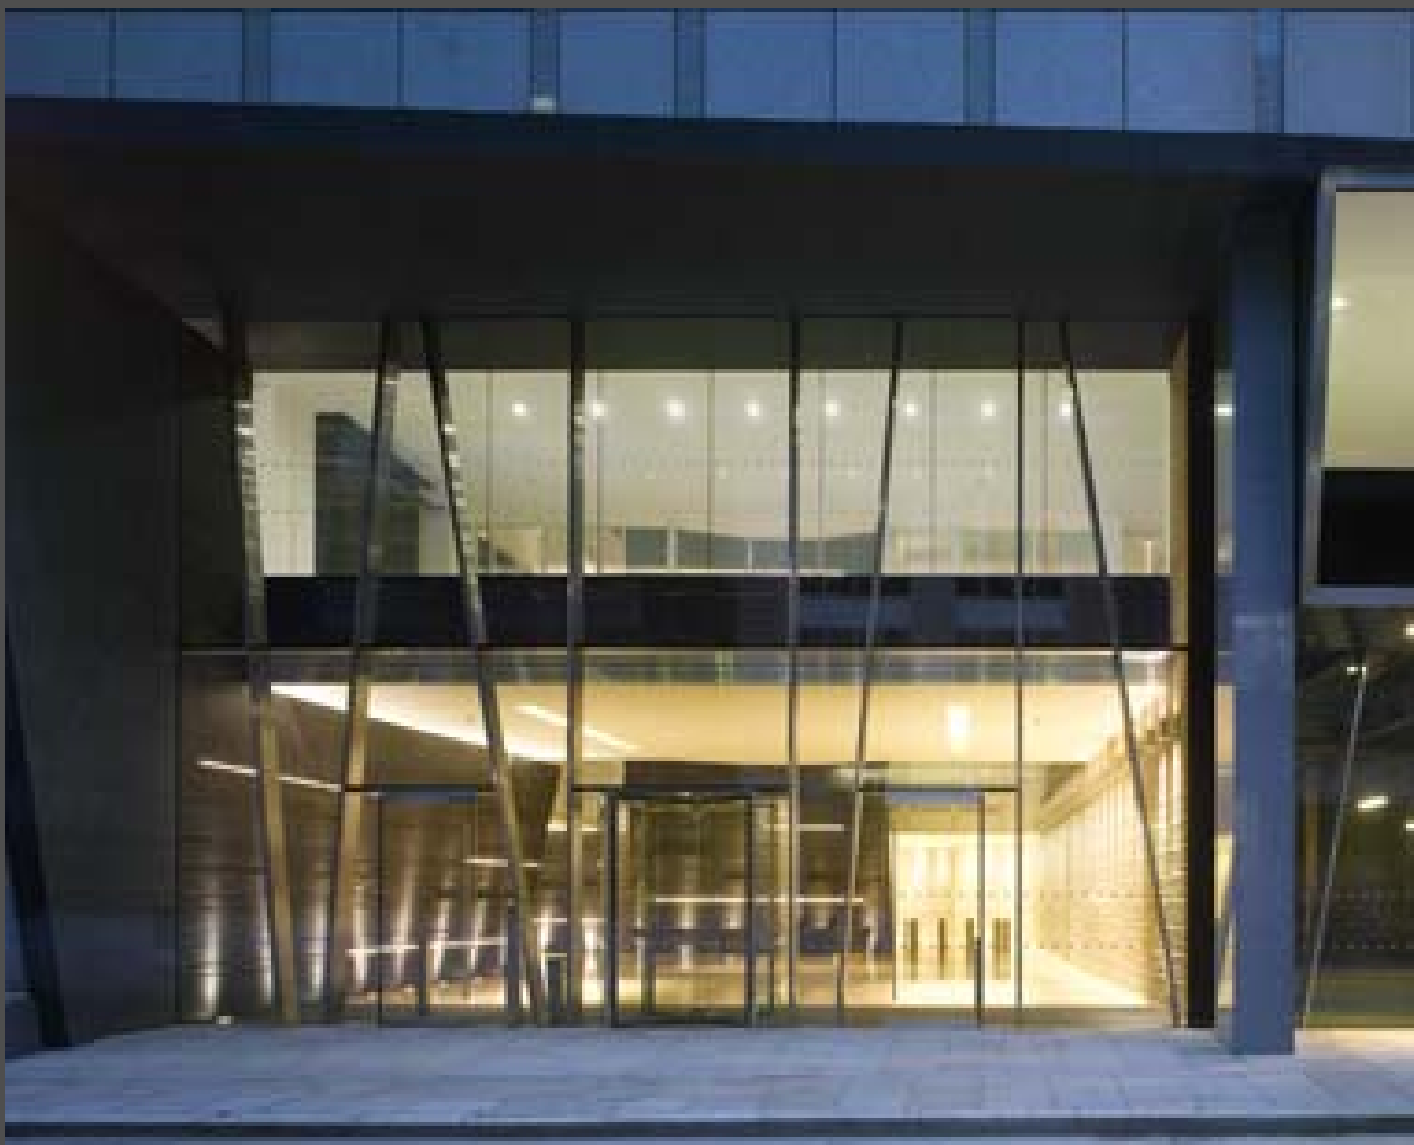
The unwelcoming and opaque front entrance (above) before replacement with the transparent and modern improvement (below.)

Two bays of cladding were removed and a new 2-storey fully glazed entrance was inserted featuring a raking projecting stone canopy announcing the entrance and providing a new identity. This element continues inside the building as a feature angled wall, which wraps around a new waiting area, before turning up behind the cantilevered reception desk to soar 6-storeys upwards and outwards to the top of the atrium.

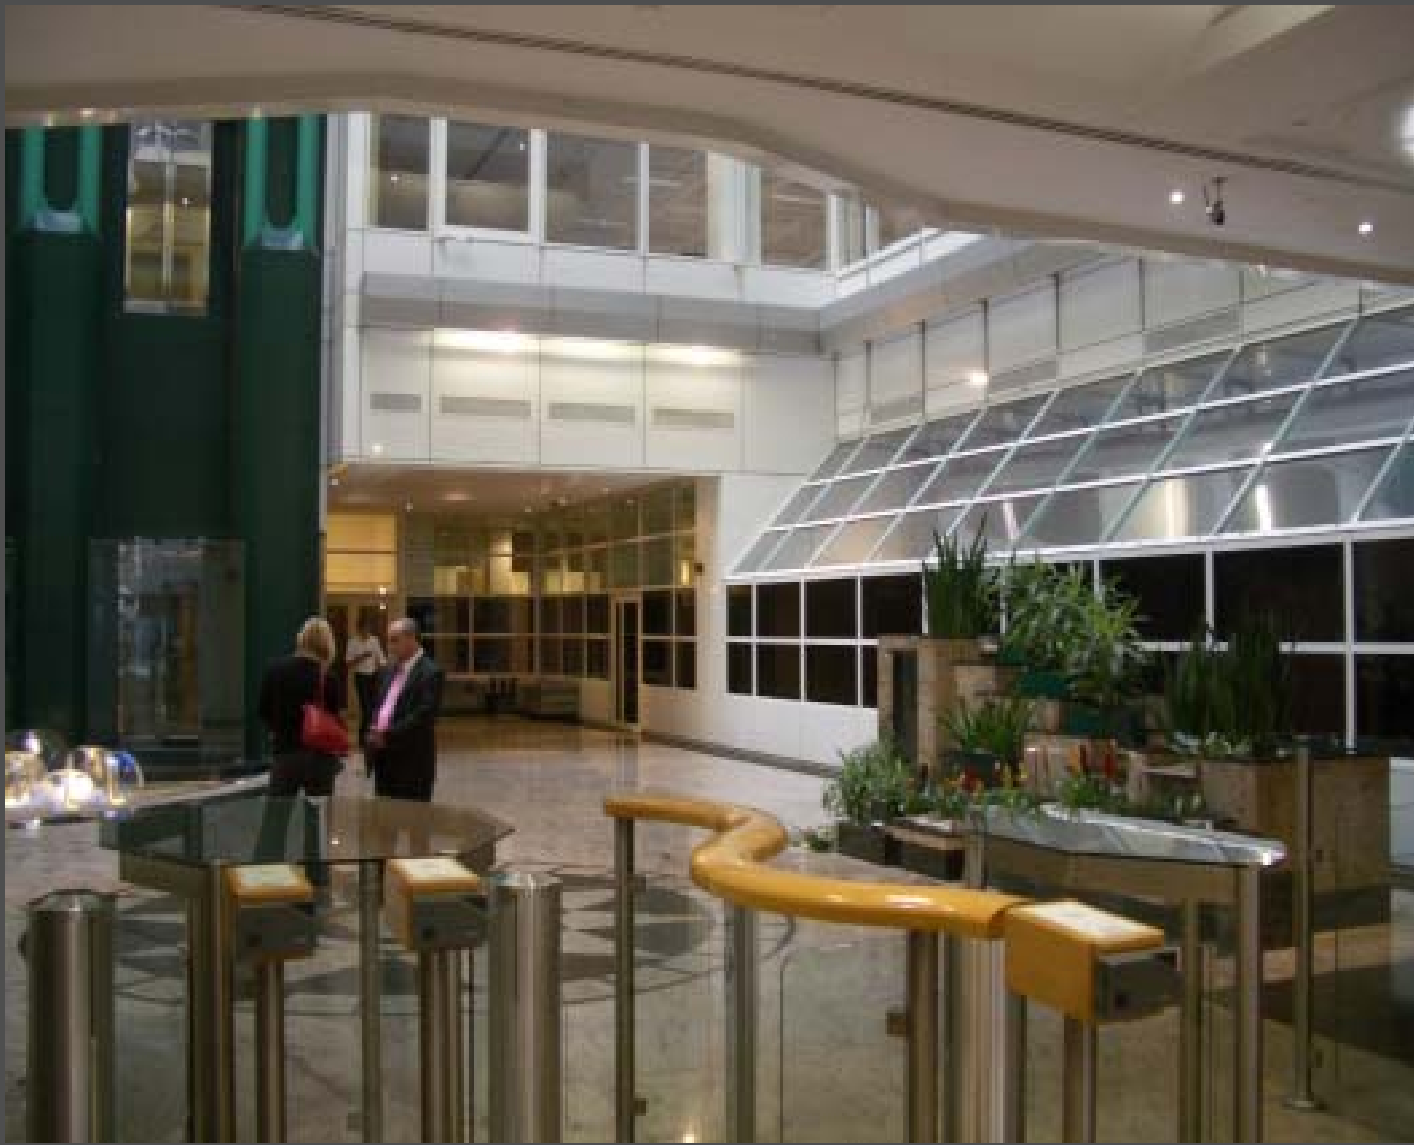
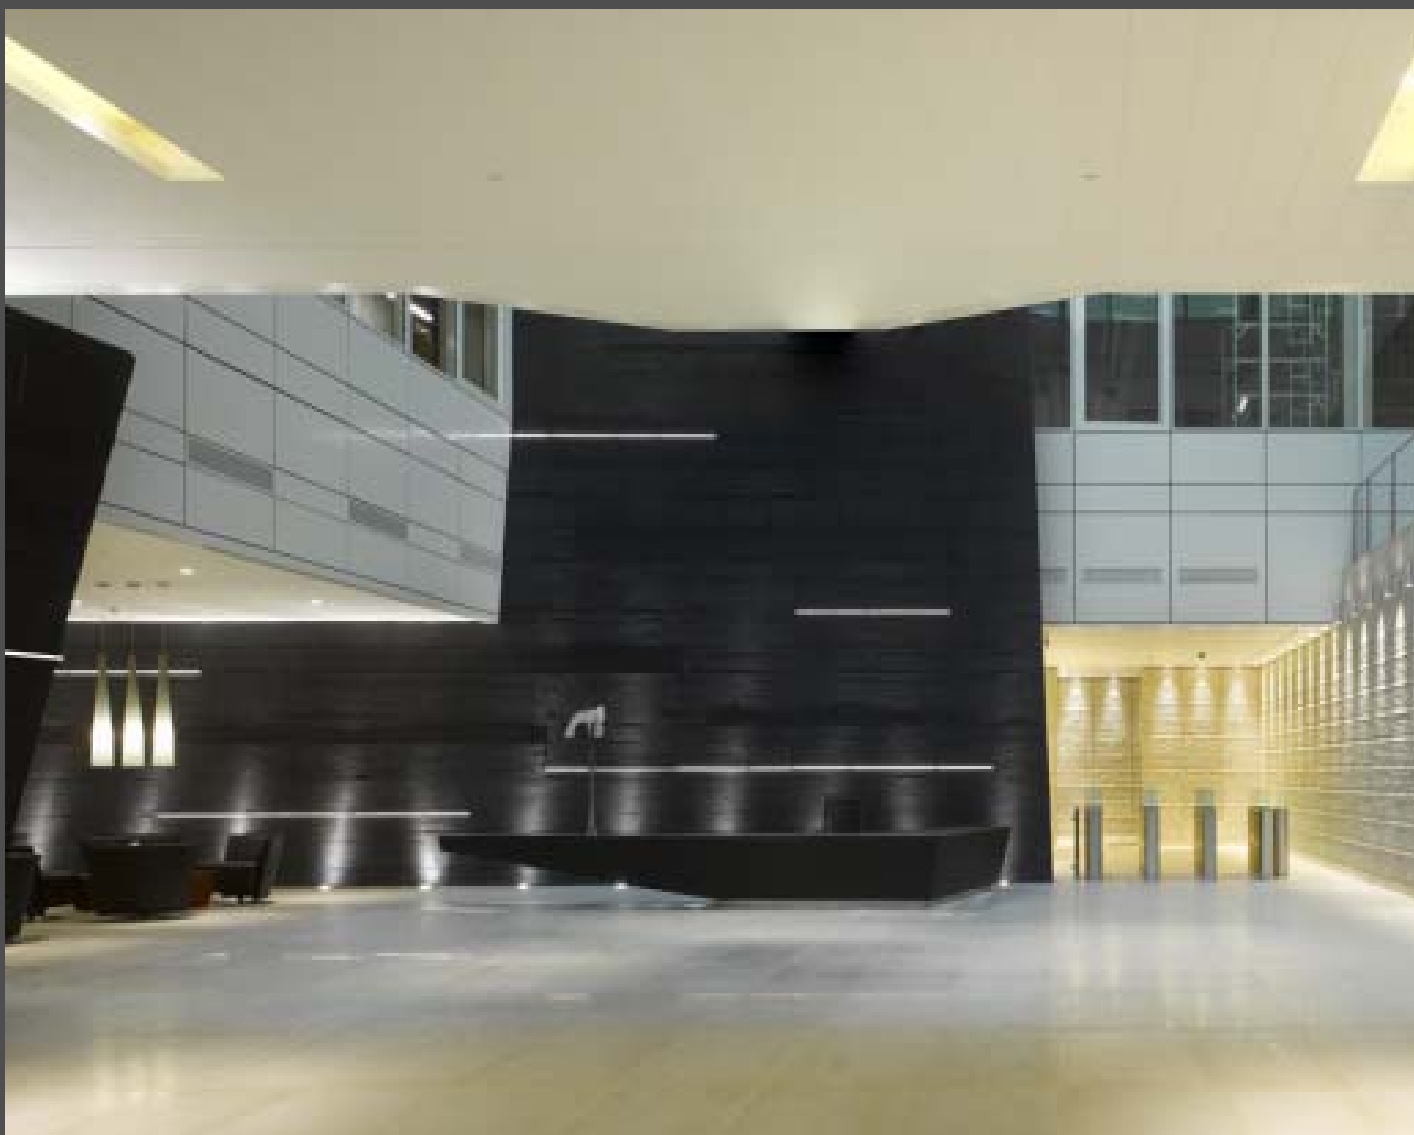
The original reception (above) was limited to a small, low ceiling area in front of the security barriers which has now been transformed by fresh, dramatic new finishes (below.)

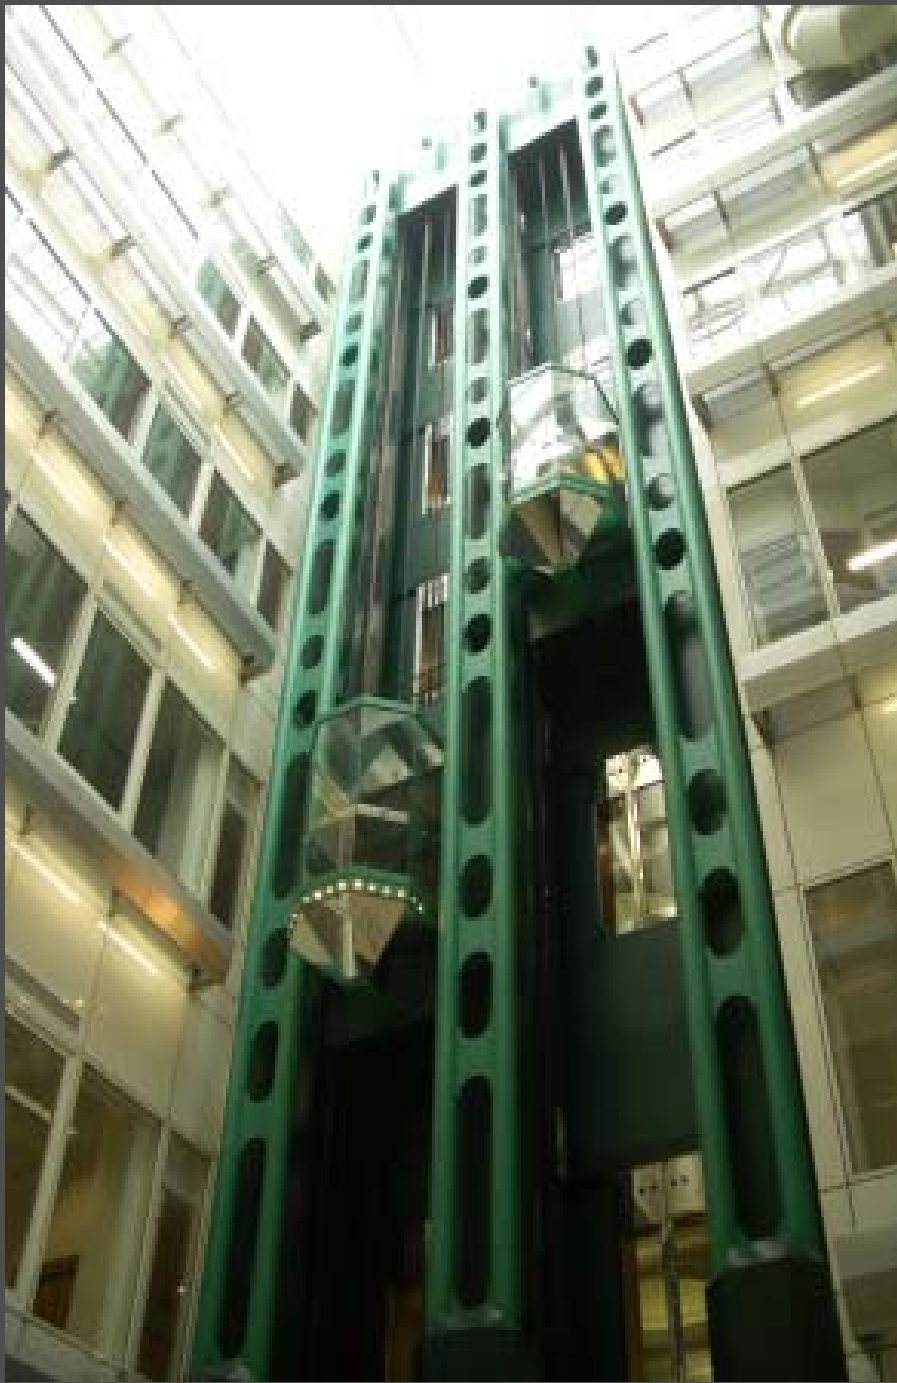
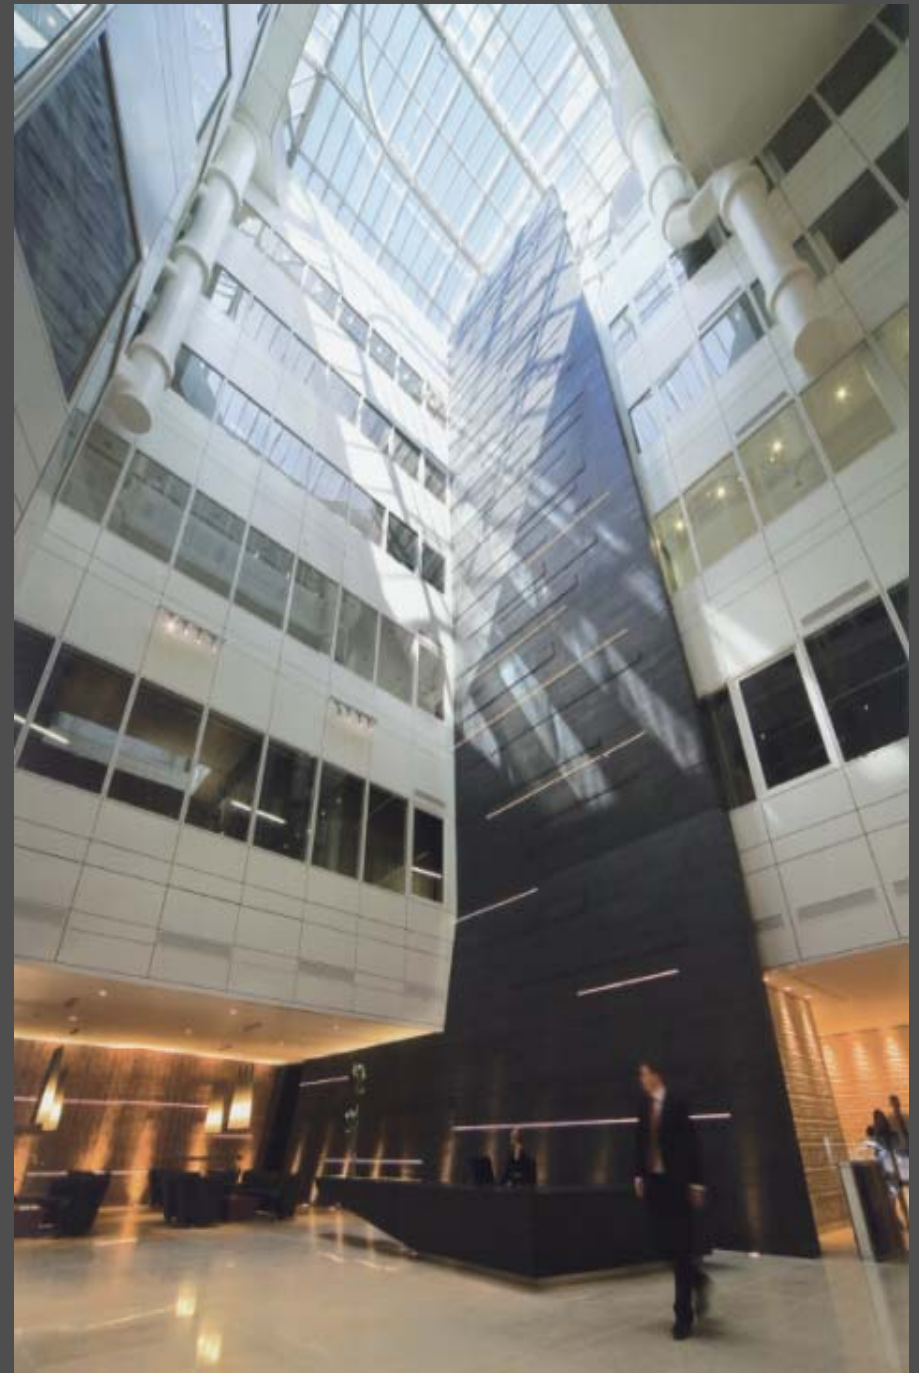
The original atrium (left) was cluttered by heavy wall climber lifts and cleaning access balconies which shaded the space.

In the redesigned atrium (below) the balconies were removed, the facades re-finished and new lifts installed behind the feature wall, which includes custom designed LED lighting in slots in the stone.

In the atrium the obsolete facade access balconies and bridges were stripped out to improve daylight to the base of the atrium. A series of lightweight decorative terraces were reinforced and clad in wood to provide new breakout spaces which now offer interesting perspectives from the office floors. A secondary atrium was punched through two floors to bring light into the deepest spaces.

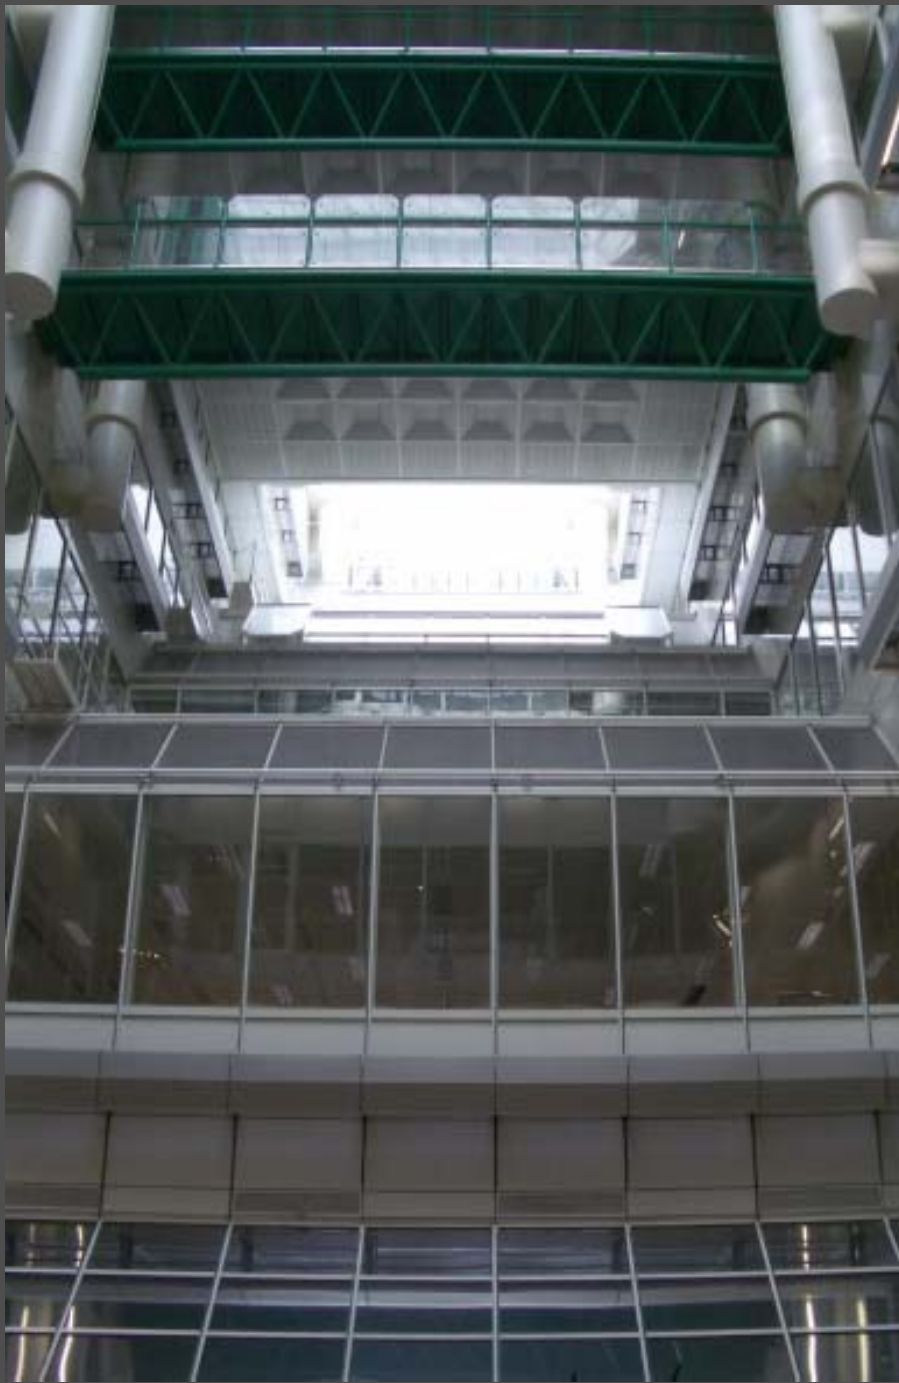
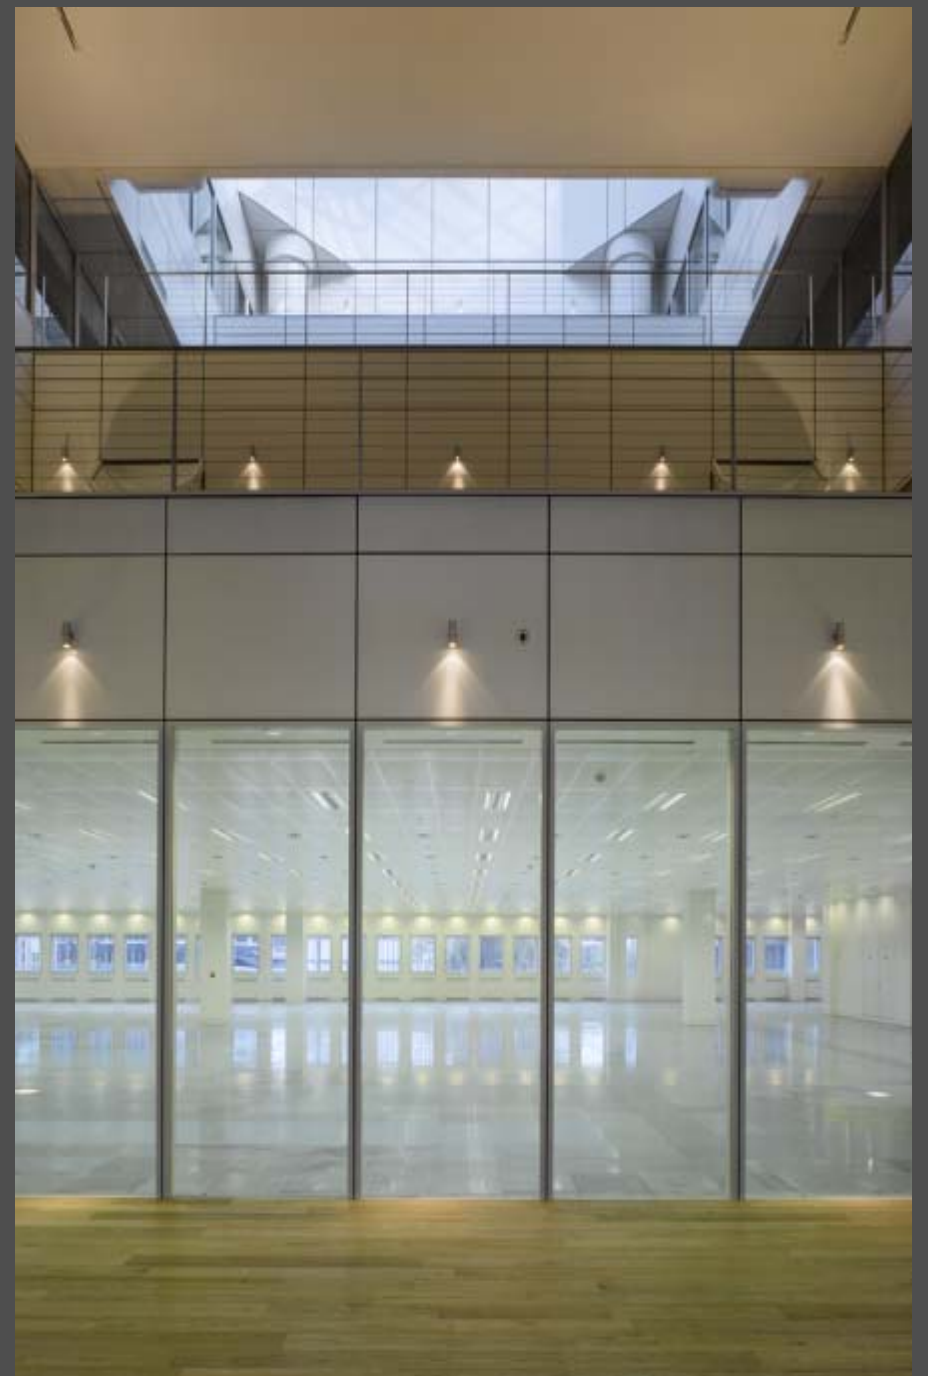
The light in the original atrium (left) was also restricted by a dark overhanging soffit and obsolete bridges above a cascade of inaccessible glazed elements.

The new design (below) removed the bridges, simplified and illuminated the soffit, and squared off the terraces to provide break out space to the offices.

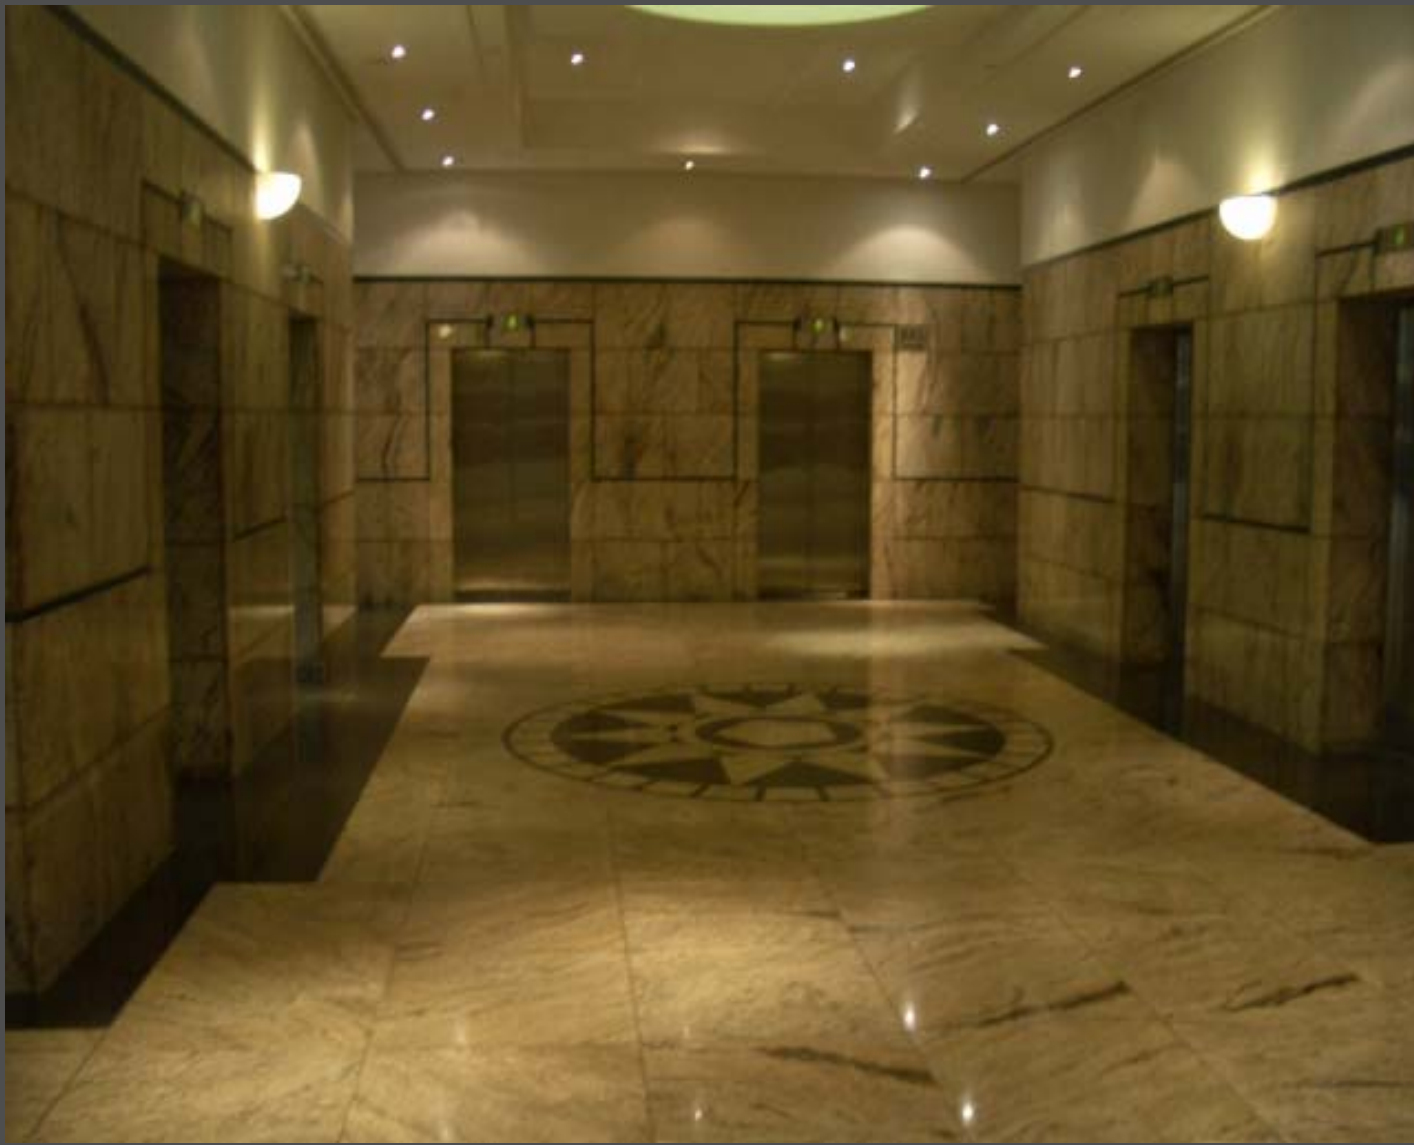
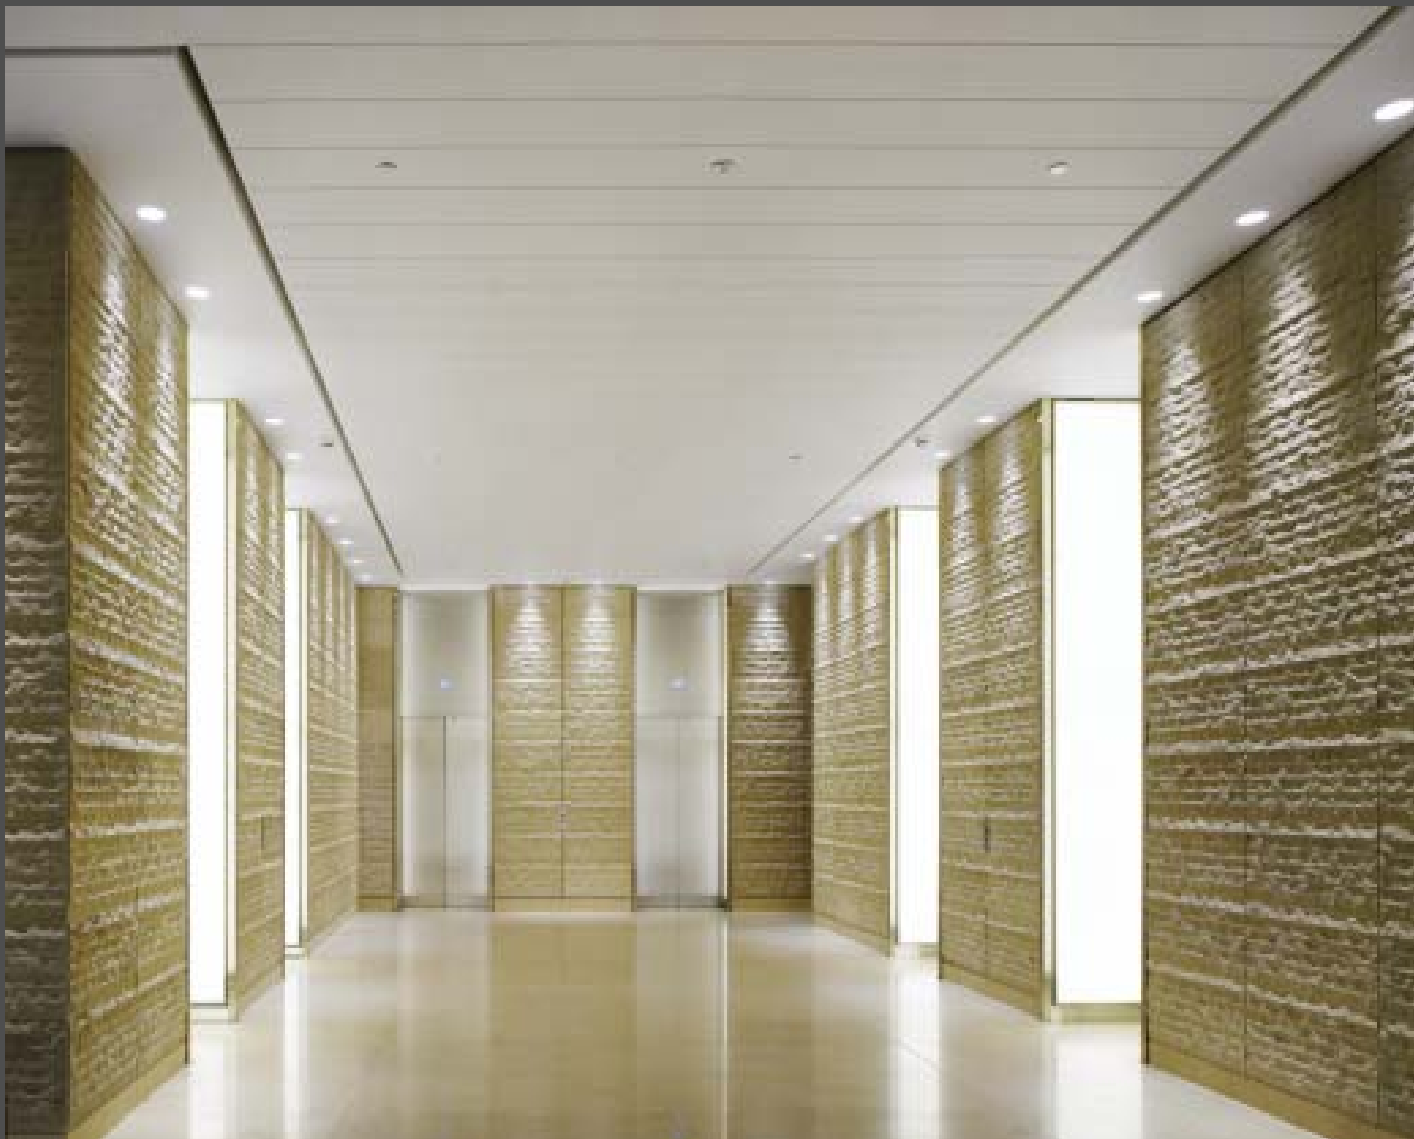
The original lift lobby (above) was dark and over-monumental in its use of marble.

The new (below) is cleaner and simpler with an increased ceiling height.

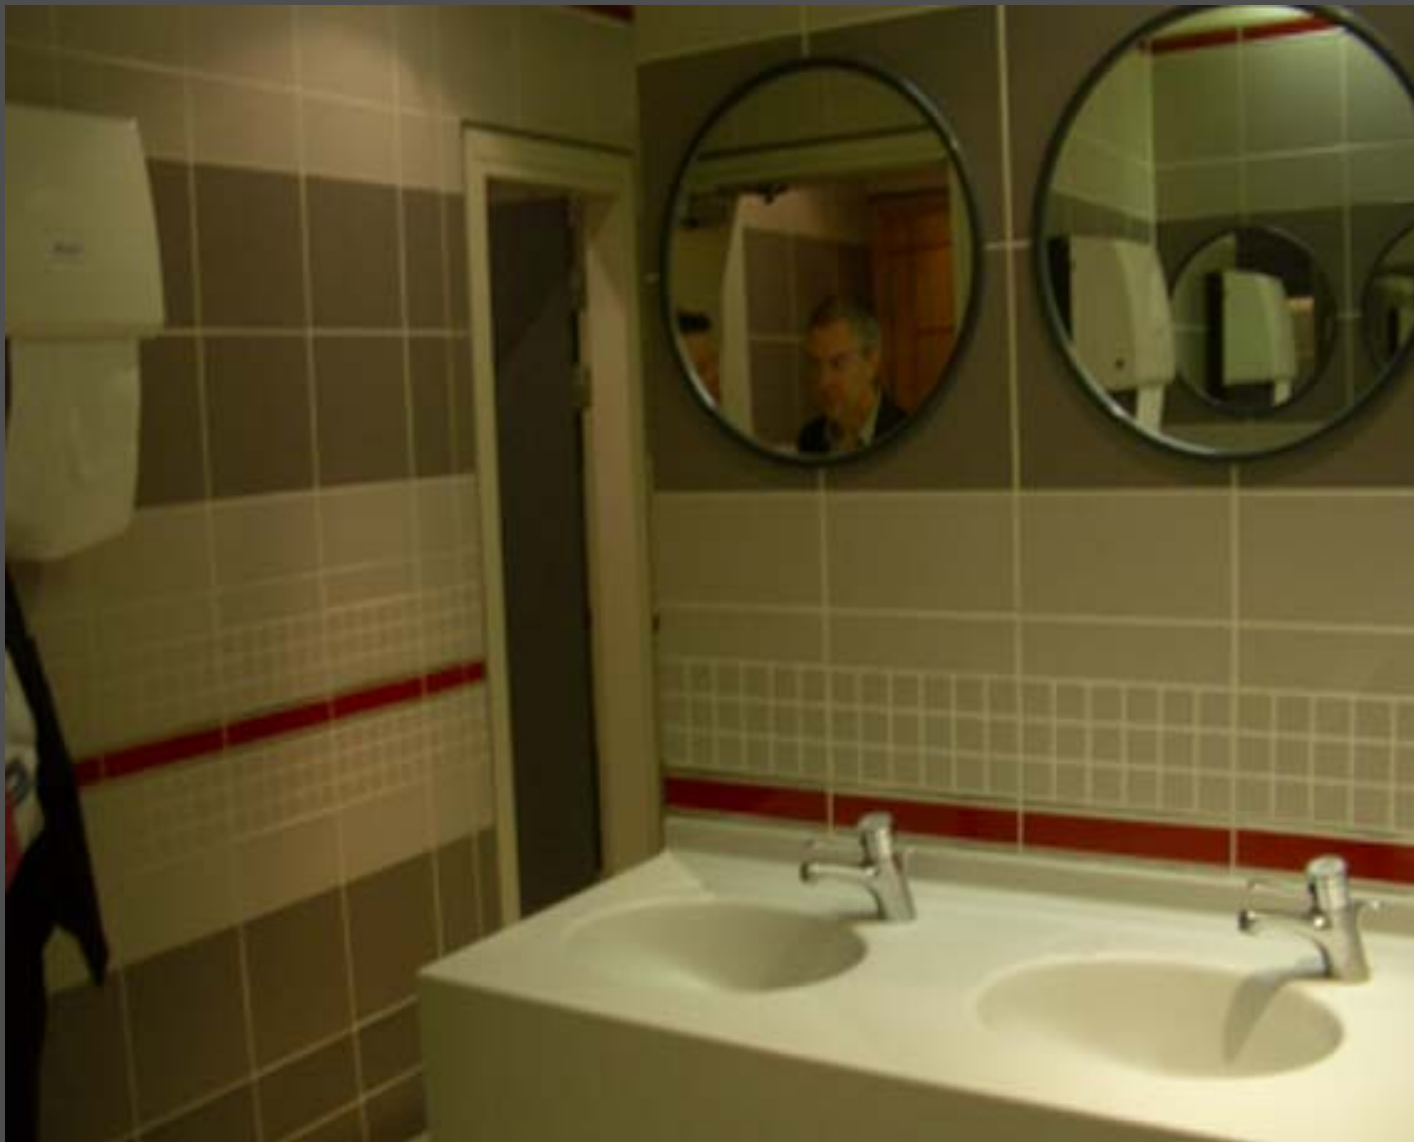
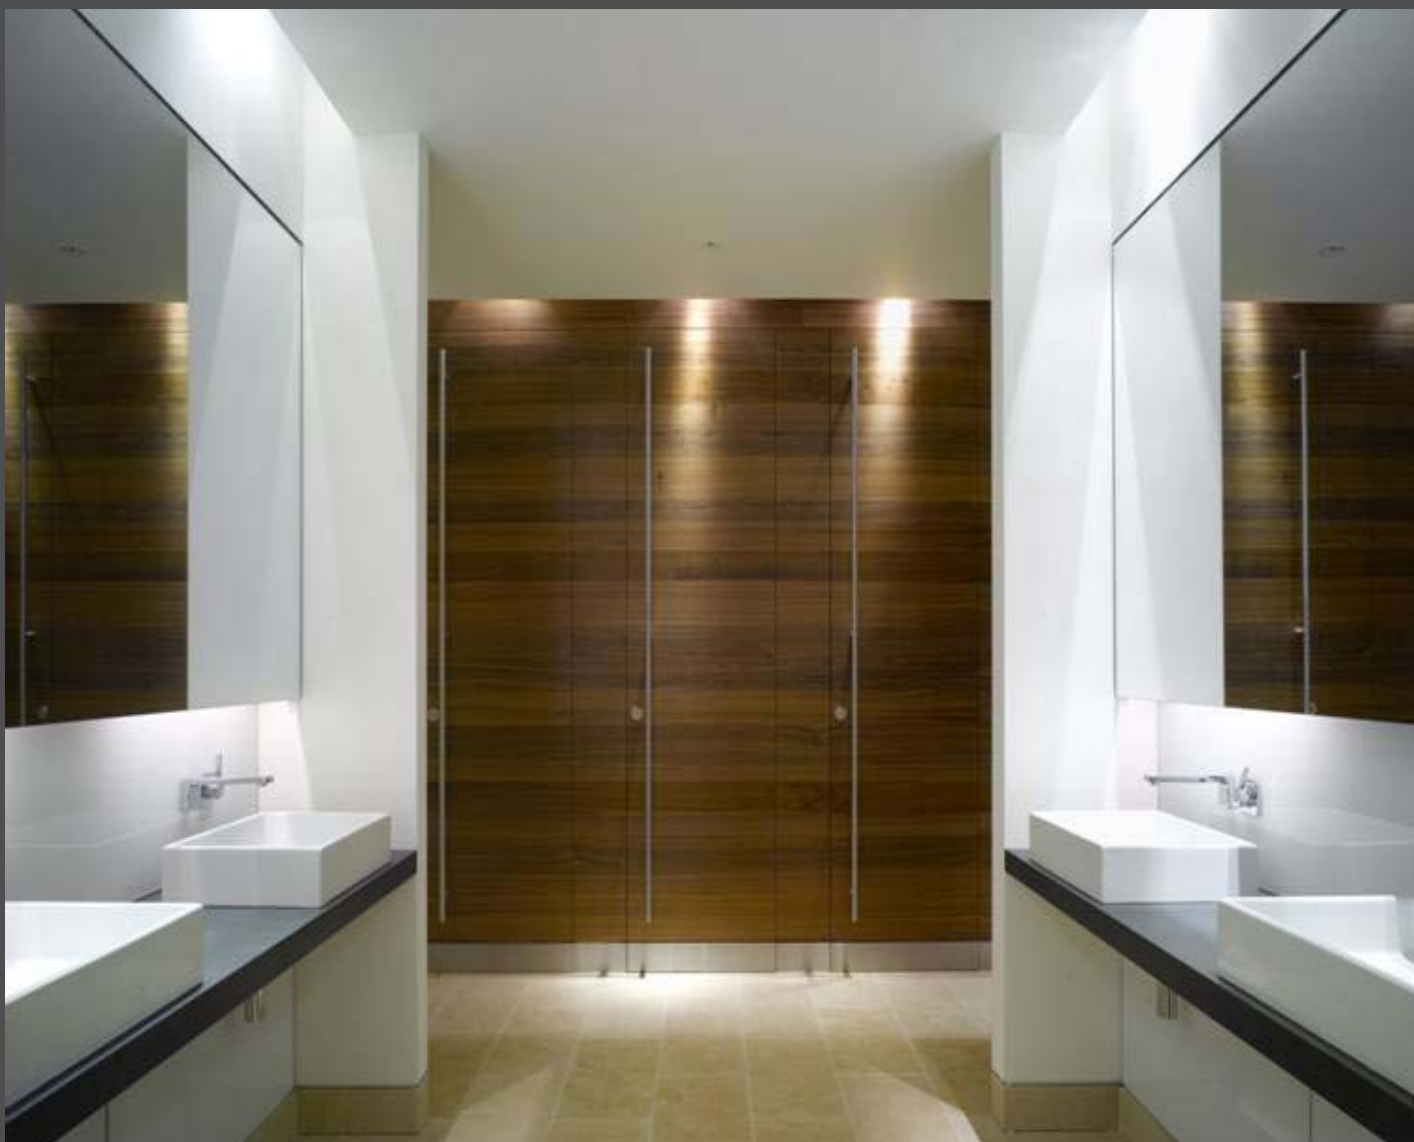
The original washrooms (above) were very tired and dated.
The new (below) use natural wood and stone in a fresh, modern, way.

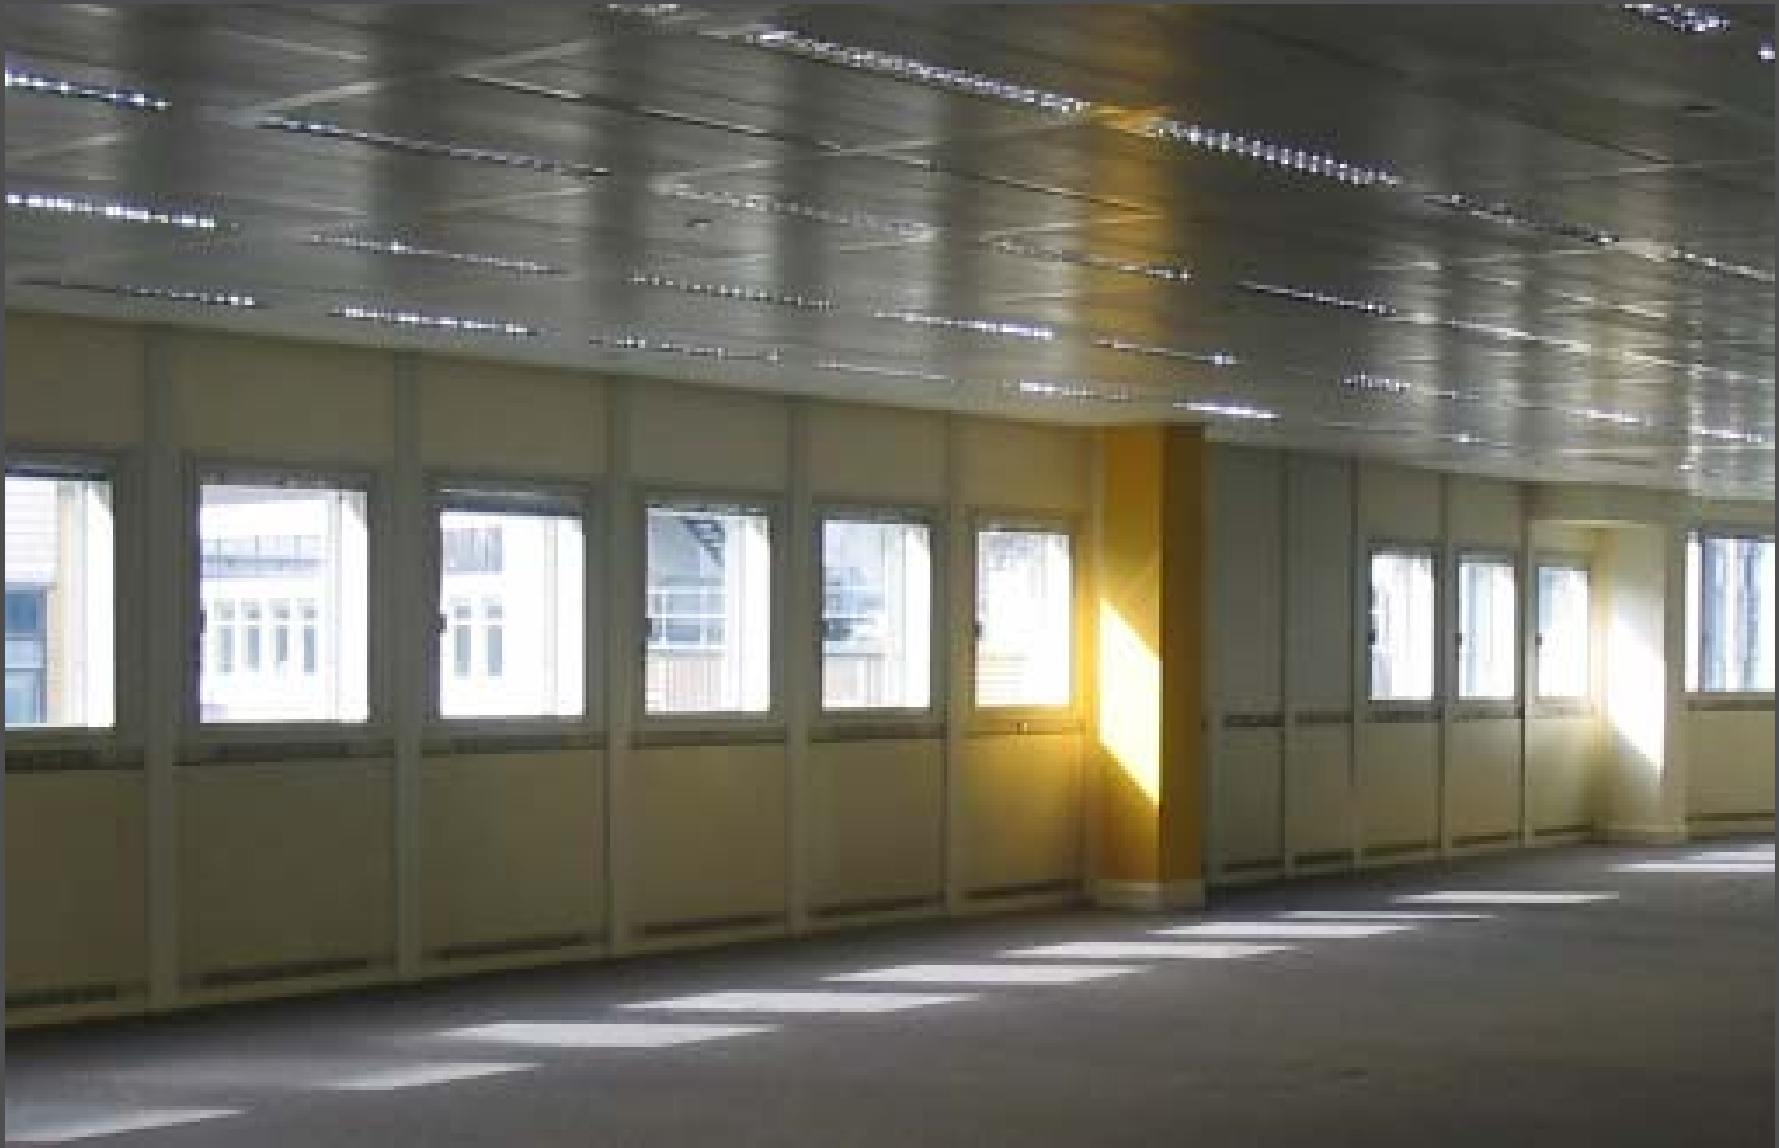
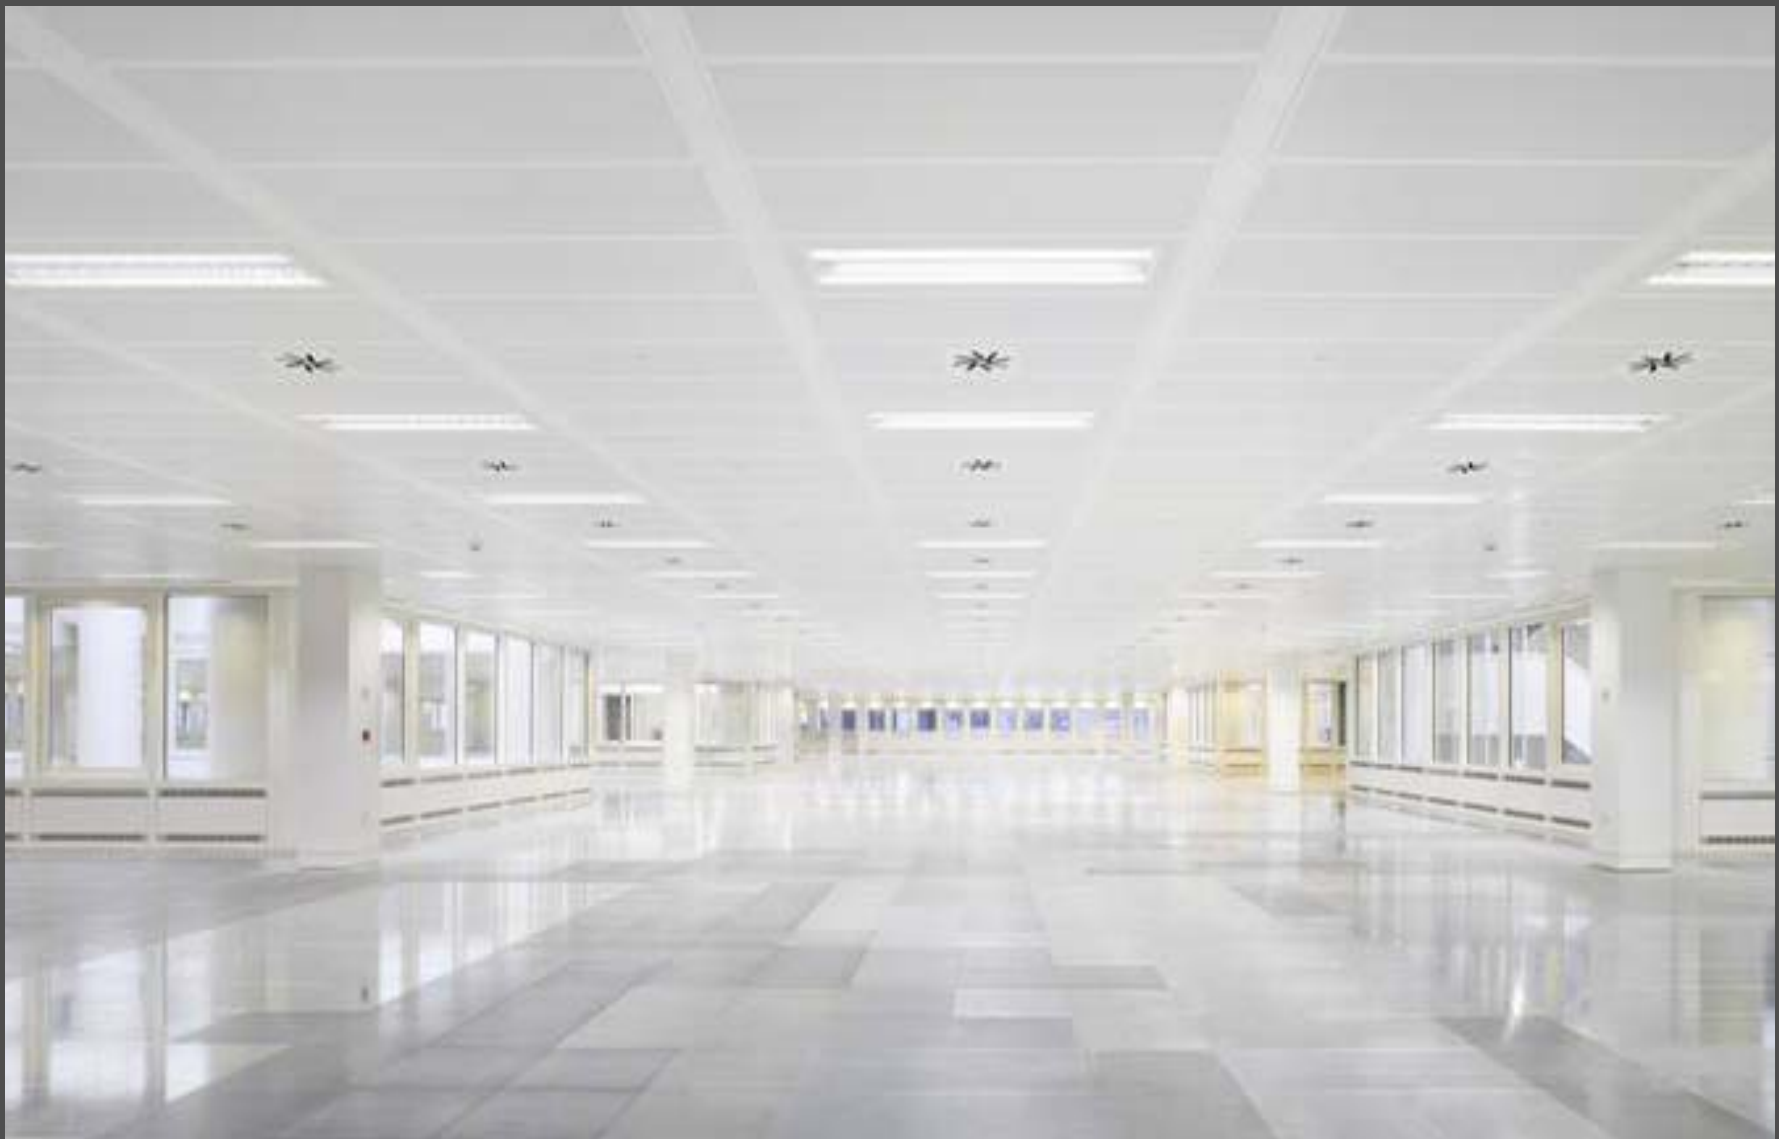
The perimeter to the offices (above) was fragmented with different parts.

New plasterboard lining (below) simplifies the perimeter and a new metal ceiling with low energy lighting enhances the space and illumination.
